# **Sydney Football Stadium Redevelopment Stage 2 Environmental Monitoring Summary – June 2022**

**Author: Holly Hofland  
Date: 20 July 2022**

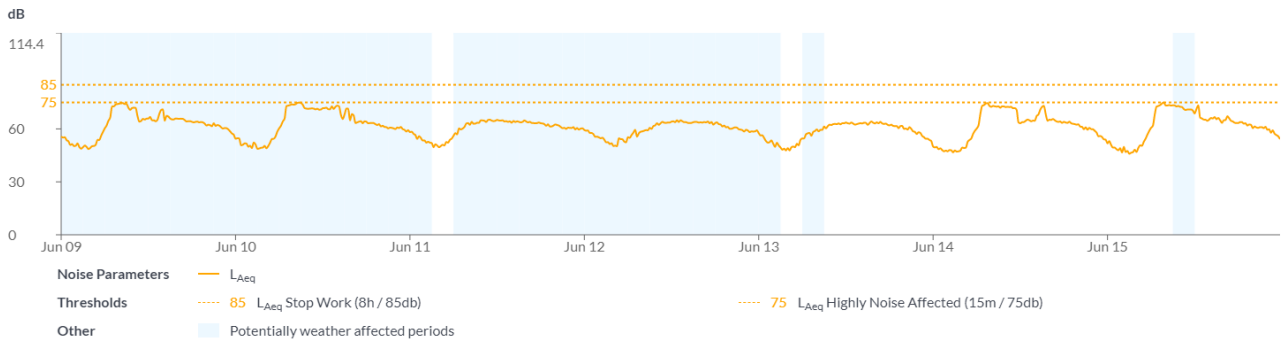
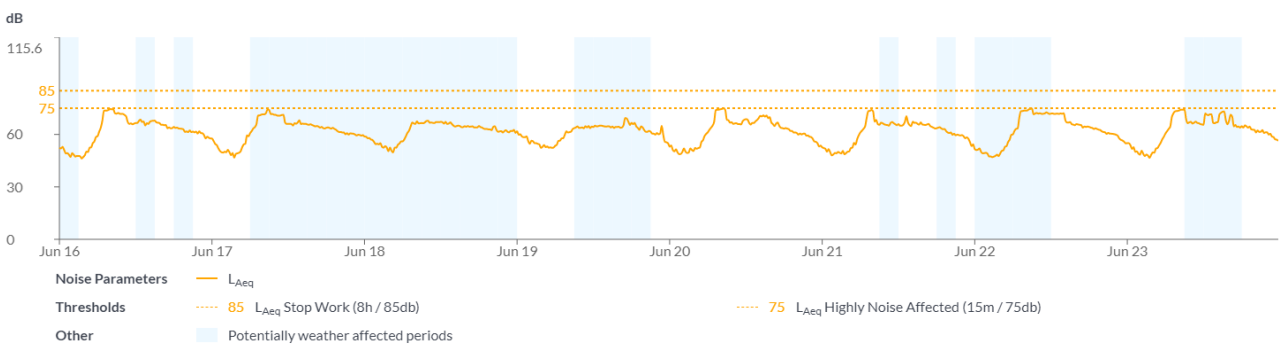
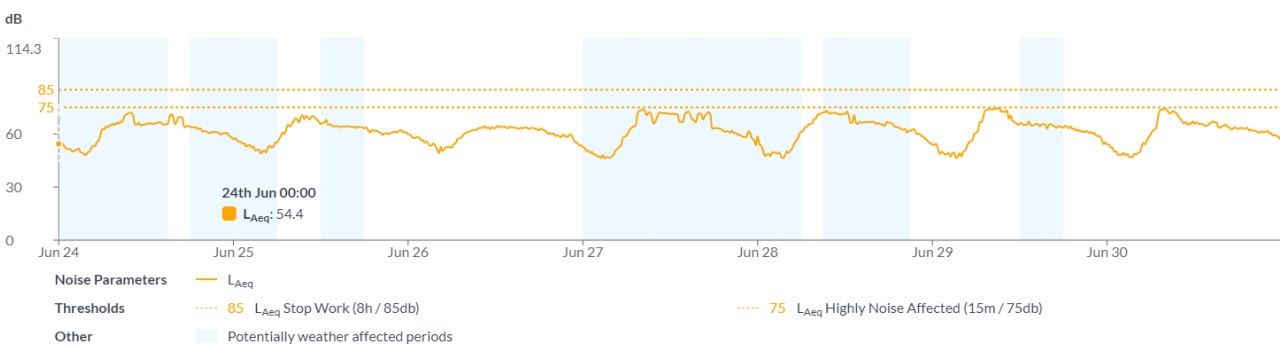
Works were generally compliant with the criteria. There were no exceedances of the Highly Noise Affected threshold related to SFS works at the KCC monitor. The predominant source of noise was due to peak hour traffic. The exceedances detected at the Gatehouse monitor were due to a vacuum truck being utilised less than 3m from the monitor. Attended monitoring was undertaken at the closest residential receiver and showed no exceedance of the Highly Noise Affected criteria.
