Angus Moreton  
Senior Project Manager  
Lendlease, Building

**RE: WESTERN SYDNEY STADIUM, PARRAMATTA  
HISTORICAL ARCHAEOLOGY – SSD 8175  
PUBLIC DOMAIN STADIUM BUILDING WORKS**

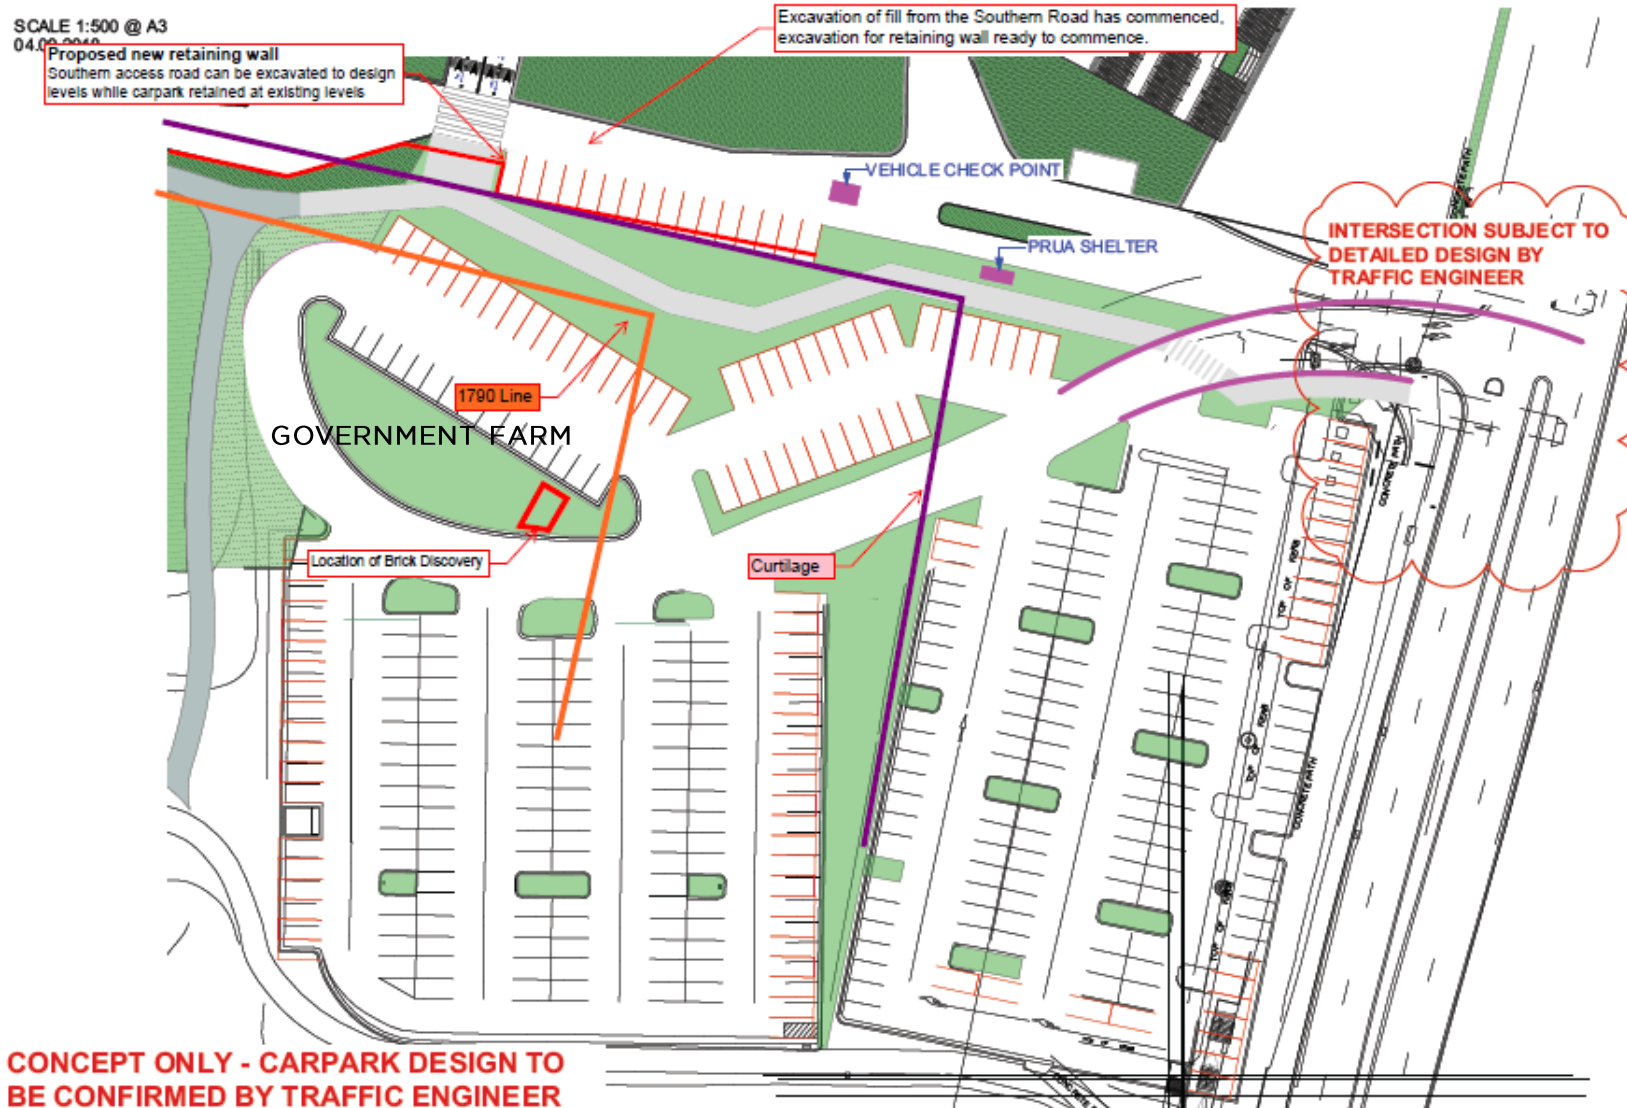
Figure 1: Amended southern carpark redesign showing the outline of the predicted location of the Government Farm (orange) and the trench where the relics were found, the curtilage for the Government Farm (purple) and the area of excavation. The retaining wall and reduction of levels are to the north of the curtilage. Lendlease plan.

Stage 3 testing in the southern carpark was undertaken as the original cut and fill design involved reduction of this area by up to 1.5m. The testing identified the presence of relics considered to be associated with a Government Farm building (1788-c.1810) (Figures 1). The discovery of these relics was reported to the Heritage Division, OEH on 25/7/2018, as required by the project approval. Following considerable redesign in the southern carpark to avoid impacts on the State-significant archaeology, as per the CoA SSD 7543 MOD 1 B14,

The key aspect of the redesign involved maintaining the carpark levels at the current RL, some minor resurfacing but no reduction of levels, and building a retaining wall outside the curtilage of the Government Farm footprint so a road can still be built around the Western Sydney Stadium (Figure 1, 2, 3).

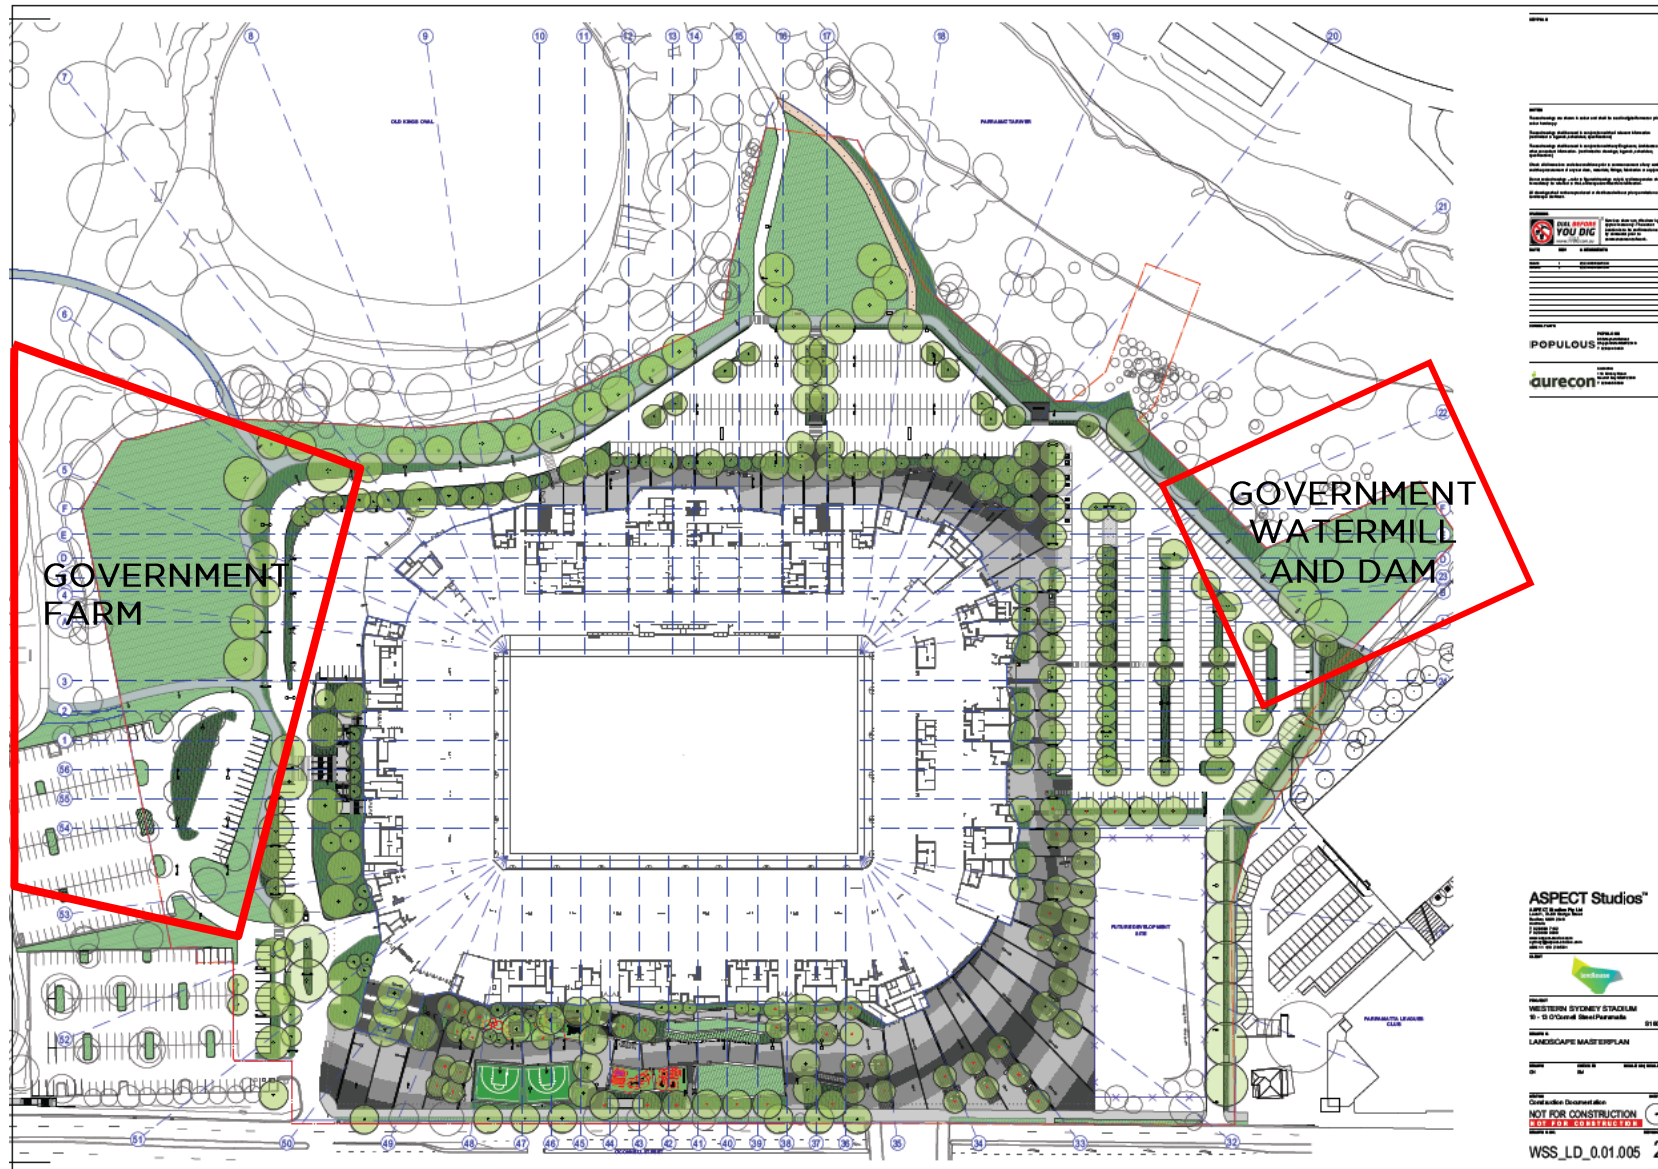
Figure 5:  
Plan showing  
proposed  
new trees  
(green  
coloured)  
to be planted  
across the  
Western  
Sydney  
Stadium  
Landscape  
Masterplan.

Tree planting within the Southern Carpark was redesigned based on the results of the Stage 3 testing program. Figures 4 and 5 shows the latest tree removal and planting design.

- **Six new trees** will be planted in this northern section of the playing field (Figure 5). This is in an area which was reduced and all archaeological material removed during the early works program (Figure 3).

- Tree removal (10 trees) within the southern carpark will involve cutting of the tree down to ground level and grinding out the stump but no excavation (Figure 4).
- The tree planting (Figures 5, 6) involves approximately 8 to 10 x 100L trees within the northern carpark and to the north.
- Much of the archaeology in this area is a mill dam which was infilled c.1960s with further landscaping in the 1980s (Casey & Lowe Jan. 2017:87; Figure 7).
- The limited planting of these 8 to 10 trees with holes 930mm diameter and 500mm depth are considered to be minimal in relation to the nature of the dam, with much

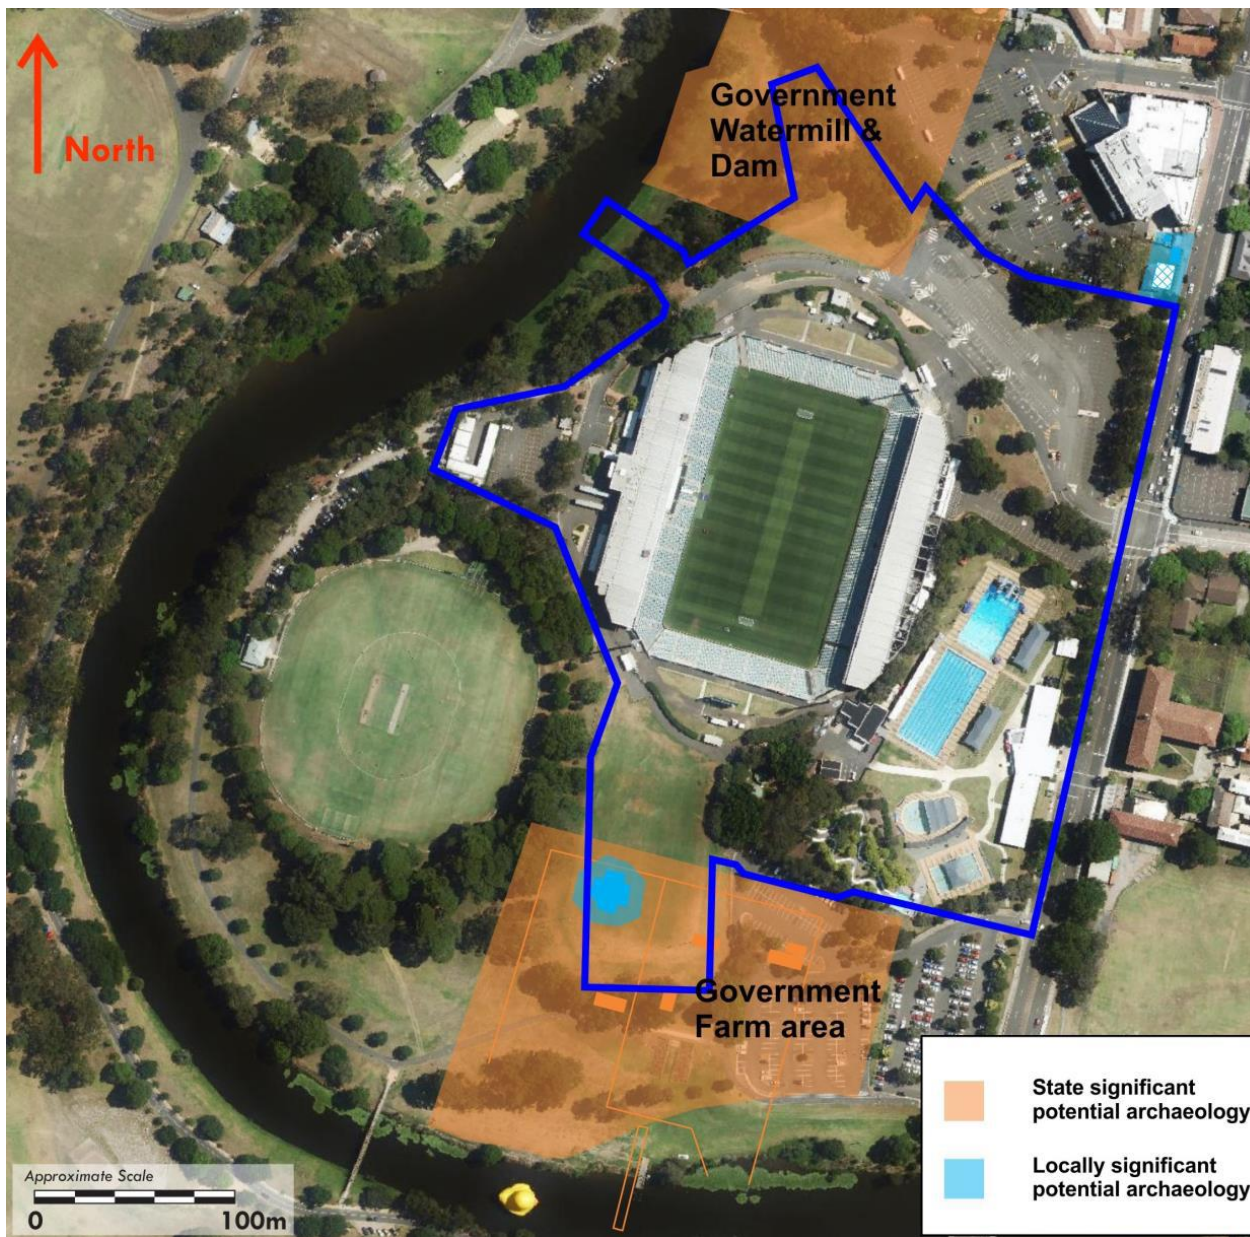
Figure 6: Plan from Archaeological Assessment showing the location of the Government Watermill and Dam. Casey & Lowe January 2017: 5. Casey & Lowe January 2017 *Western Sydney Stadium, Historical Archaeological Assessment & S96 Modification Heritage Impact Statement*, for Lendlease.

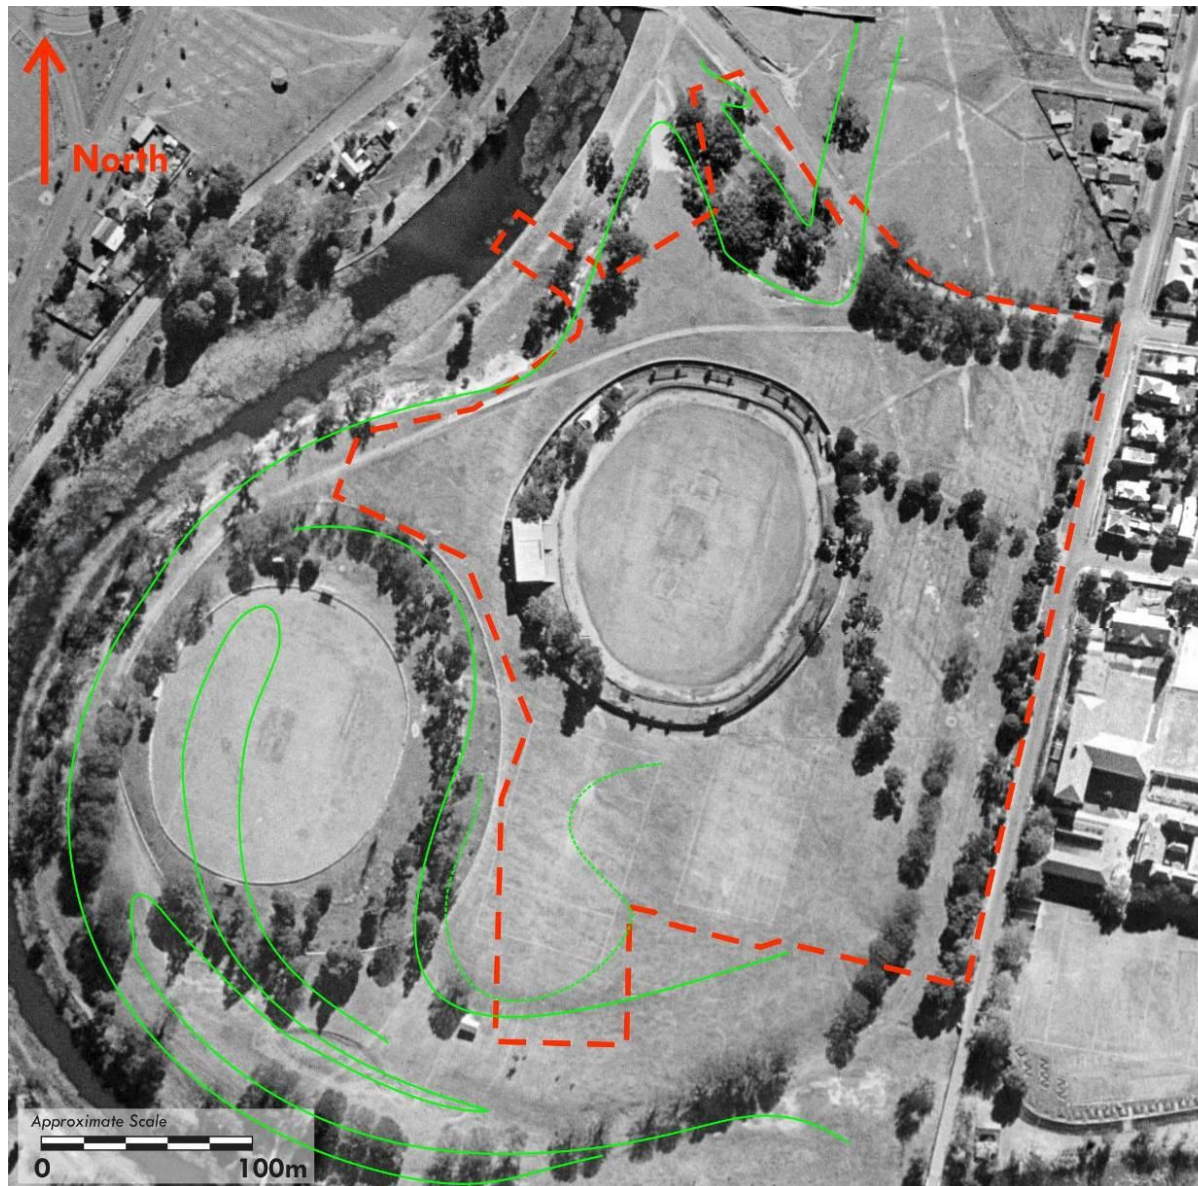
Figure 7: 1943 aerial photograph. Green lines representing the breaks of slope shown on the 1887 crown plan have been added. Study area outlined in red. NSW LPI Six Maps viewer. Casey & Lowe 2017:80. Casey & Lowe January 2017 *Western Sydney Stadium, Historical Archaeological Assessment & S96 Modification Heritage Impact Statement*, for Lendlease.
